**Flood Control Project Maintenance  
Levee Inspections**  
**LMA District Cover Sheet**  
**Spring 2011 Levee Inspection Results**

**Reclamation District No. 2060 Hastings**

**Levee Inspection Report By Mile - Spring 2011**

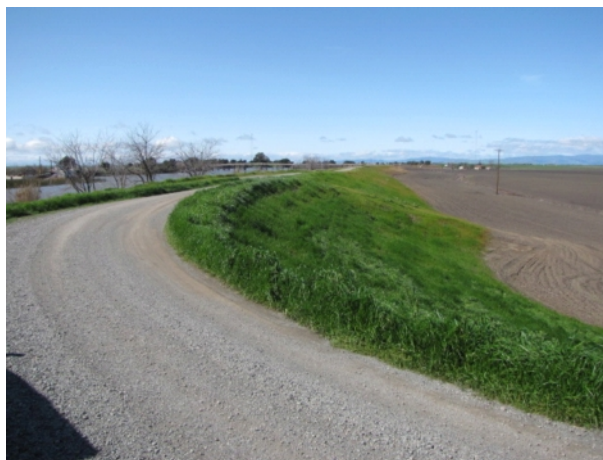
phillips\_s\_20110314\_193.jpg

Levee Mile Report Line	1
Start Levee Mile	0.00
End Levee Mile	0.00
Location	Land Side
Category	Earthen Levee
Item	Vegetation

3-08-2011 standing on landside of unit 1 RD 2060 looking downstream at levee.

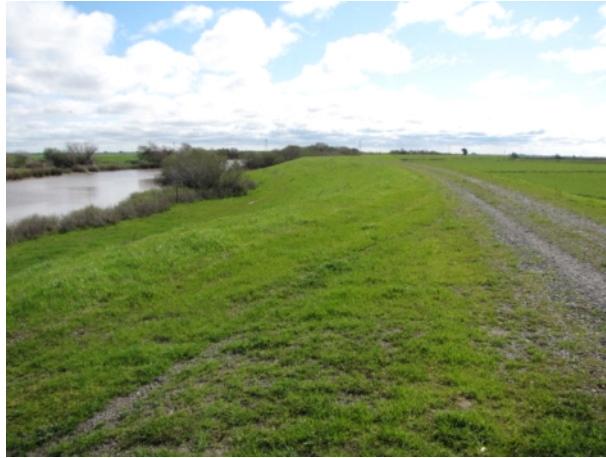
phillips\_s\_20110314\_194.jpg

Levee Mile Report Line	1
Start Levee Mile	0.00
End Levee Mile	0.00
Location	Water Side
Category	Earthen Levee
Item	Vegetation

3-08-2011 Unit 2 RD 2060 standing on waterside of levee slope looking downstream. Photo shows minimum growth of grasses on levee slope and crown roadway.

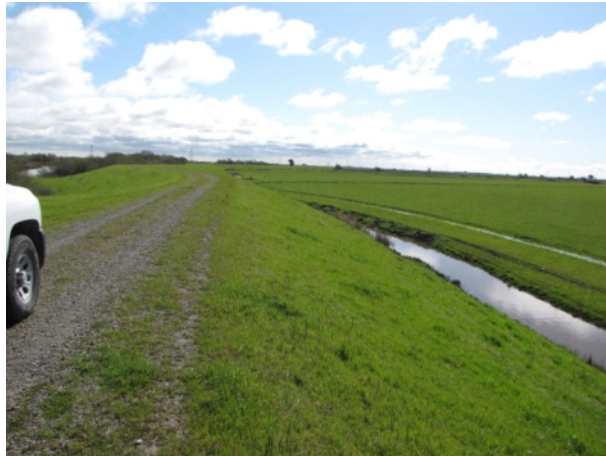
phillips\_s\_20110314\_195.jpg

Levee Mile Report Line	2
Start Levee Mile	0.00
End Levee Mile	0.00
Location	Land Side
Category	Earthen Levee
Item	Vegetation

3-08-2011 standing on landside of RD 2060 looking downstream. Unit 2

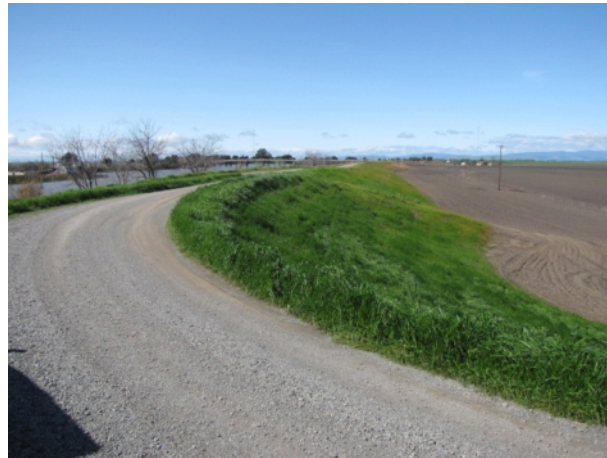
phillips\_s\_20110412\_252.jpg

Levee Mile Report Line	1
Start Levee Mile	0.00
End Levee Mile	0.00
Location	Land Side
Category	Earthen Levee
Item	Vegetation

Photo here shows view of land side looking downstream from levee mile 0.00 of RD 2060 Unit 3. This photo was taken 3-8-2011.

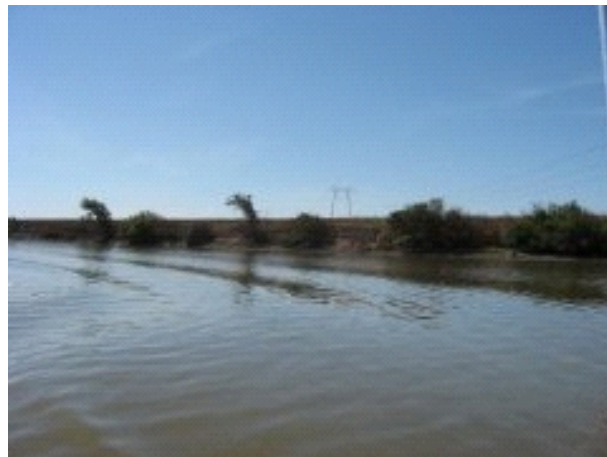
phillips\_s\_20110228\_159.JPG

Levee Mile Report Line	5
Start Levee Mile	1.56
End Levee Mile	1.71
Location	Water Side
Category	Supplemental
Item	USACE Erosion Survey

2009: no berm, 2:1 slope, slumping, clays and silts, 0.27 ft/s [2009 SiteID:CHS\_23-6\_R]

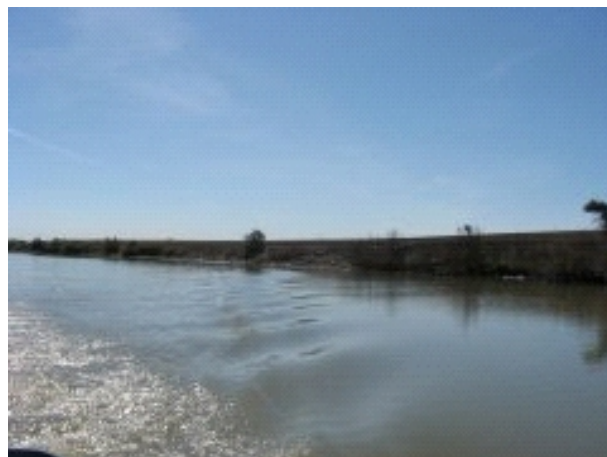
phillips\_s\_20110228\_160.JPG

Levee Mile Report Line	8
Start Levee Mile	2.19
End Levee Mile	2.24
Location	Water Side
Category	Supplemental
Item	USACE Erosion Survey

2009: no berm, 2.5:1 slope, slumping, clays and sands, 1 ft/s [2009 SiteID:CHS\_22-8\_R]
